# Case Study

Structural Health Monitoring  
Corporate Center Building (CHUBB)  
San Juan, Puerto Rico

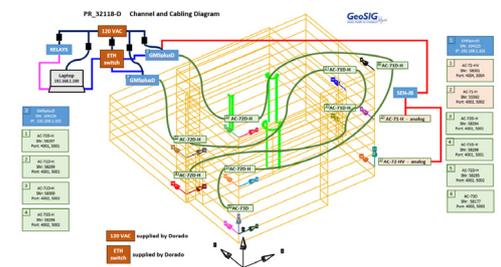
The accelerometers and digital seismic recorders are strategically placed. GeoSMART software monitors the data received from the sensors and sends an alert if exceedances are detected.

[Dorado Services of Puerto Rico](#) installed a customised SHRM solution consisting of six AC-7X accelerometers in the main office building, four AC-7X accelerometers in the parking garage structure, and two GMSplusD digital seismic recorders used to record and store data from the accelerometers. Additionally, a relay card has been installed to activate emergency risk indicator lights across all floors to notify building occupants of the status of an event, with red indicating a high risk level and green indicating low risk level and no need to evacuate.

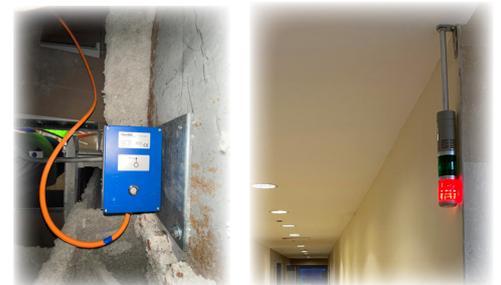
GeoSIG accelerometers (left) detect motion as part of the structural monitoring of the building. If the exceedance is deemed unsafe, red lights in the corridor (right) will alert people that evacuation is necessary.
