# Case Study

## Structural Monitoring Jakarta Cathedral Indonesia

P.T. RISEN ENGINEERING CONSULTANT  
www.risen.id

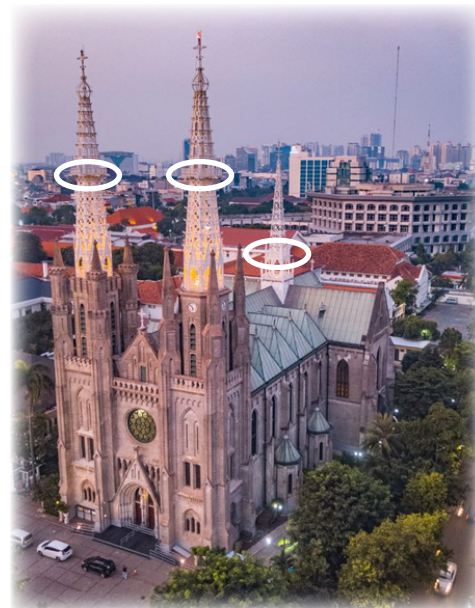
Jakarta Cathedral - sensor locations marked

There are three main spires in Jakarta Cathedral: the two tallest ones measure 60m and are located in front on each side of the main entrance. The north tower is called Turris Davidica, or "Tower of David"—a devotional title of Mary symbolizing Mary as the refuge and protector against the power of darkness. The south tower, also 60m, is called "The Ivory Tower", with the whiteness and pureness of ivory to symbolise the purity of Virgin Mary. On the Ivory Tower, there are old clocks that are still functioning as well as a church bell. The third spire, called "The Angelus Dei Tower," rises above the roof's cross intersection and measures 45m from the ground. These three towers are steel structures which stand on unreinforced masonry structures. They are the highest part of the building as well as being the most critical parts. They are of course not designed with current building codes, so it is very important to know the structural behavior of these towers, especially due to lateral loads or earthquakes. Due to the civic and historical importance of Jakarta Cathedral, the mandate was to deliver and install a vibration monitoring solution—without damaging any part of the building—with robust, long life sensors, proven to be cost effective and offering longevity.

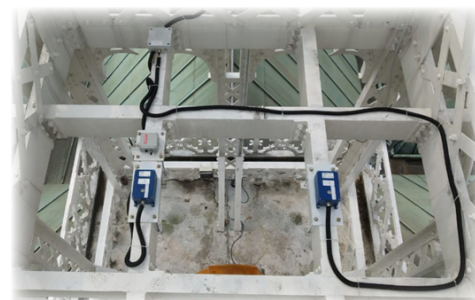
Sensors installed at Angelus Dei Tower

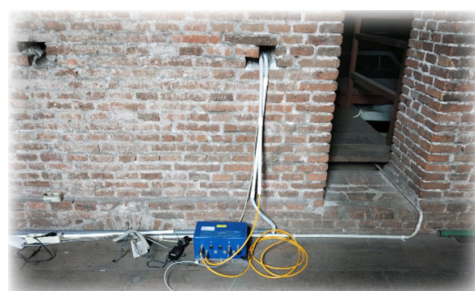
GMSplus6 data loggers are installed in the cathedral's attic and at ground floor.

The church has undergone three renovations, first in 1988, 2002 and lastly 2017. In 2017, it was decided to install a Structural Health Monitoring System. [P.T. Risen Engineering Consultant](#), with a wealth of experience in providing end-to-end customized solutions, successfully fulfilled the requirements of this highly prestigious project. The vibration monitoring solution consists of two GeoSIG [GMSplus6](#) data loggers with one internal triaxial accelerometer, three GeoSIG biaxial accelerometers and three GeoSIG uniaxial accelerometers. The tilt monitoring solution consists of three tiltmeters and one gateway. The installed vibrations solution offers reliable and continuous monitoring, providing data based on event detection. GeoDAS, a proven data acquisition and evaluation package developed by [GeoSIG](#), provides highly flexible user-friendly capabilities, graphical and analytical tools with configurable automation. For early tilting detection of the towers, wireless equipment was used as the data is collected once per hour. One tiltmeter on each tower and one gateway for collecting data from all tiltmeters was used. The tilting data can be seen in real time using a web browser as the gateway acts as a web server.
