## New!!! AC-43 MEMS based Triaxial Accelerometer

## Office Floor Vibrations: Modal Parameter Identification and Vibration Monitoring

This professional bulletin has been prepared by GeoSIG Ltd.

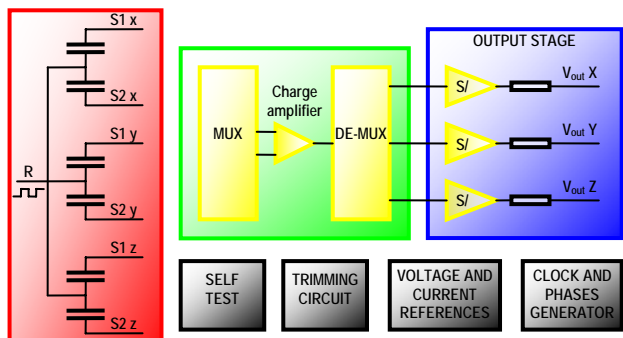
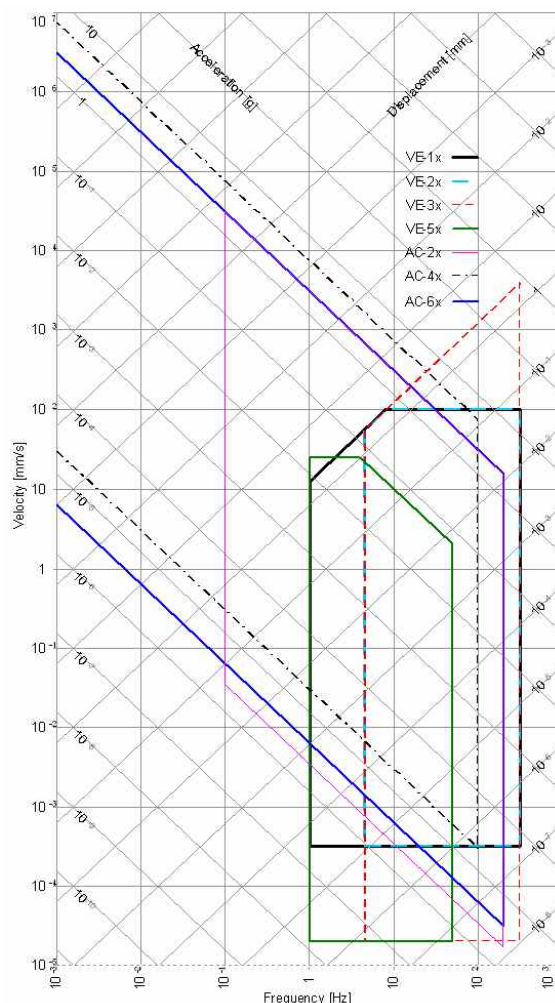
Figure 1. AC-4x in comparison with other GeoSIG sensors

The AC-43 is typically housed in the standard GeoSIG sealed cast aluminium housing with dimensions of 193 x 112 x 94 mm. The housing also incorporates a single bolt mount with three levelling screws. Stainless steel packaging options are available.

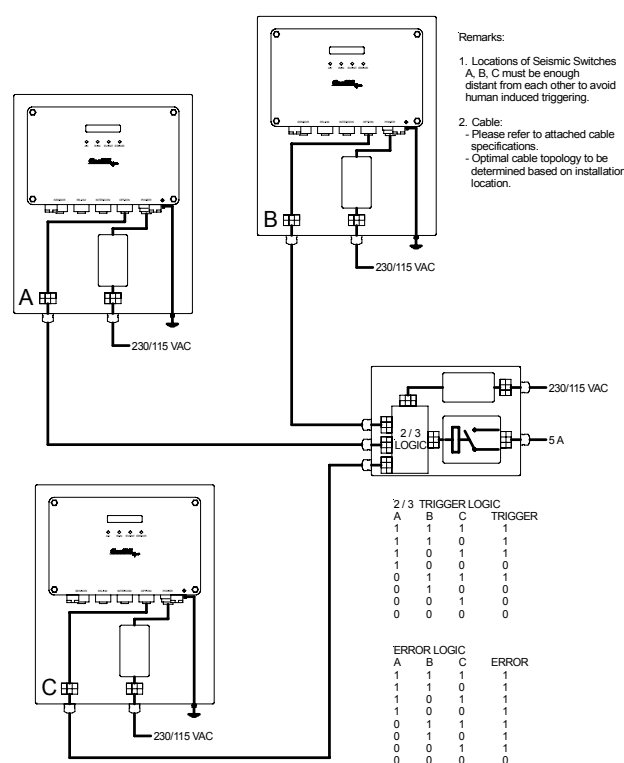
Figure 3. A sample deployment option for 2 out of 3 logic

Advanced 2 out of 3 relay logic is available for complementing the deployment of AS-1x especially in industrial shutdown operations as well as for emergency management such as in high-rise buildings, where reliability with confirmation is required.

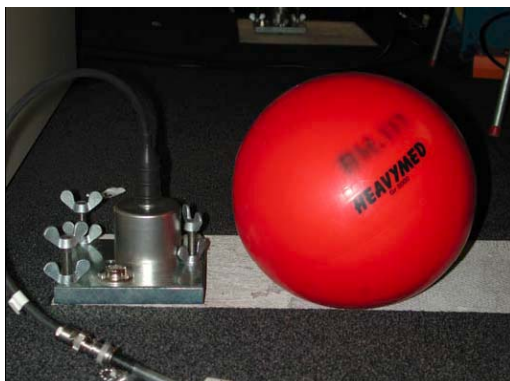
Figure 4. The medical ball used to excite the slabs and one of the accelerometers used to measure the slab response.

To identify the dynamic parameters of such a structure, experience has shown that it is a good idea to artificially increase the level of structural vibrations during the "AVT" investigation. Moving on the floor and dropping a 5 kg medical ball from a height of roughly 1 m at irregular intervals of one to four seconds has proven to be a very efficient means of excitation for concrete floors exhibiting dimensions of several meters. (Figure 4)

Piezo-electric sensors PCB 393B31 with a sensitivity of 10 V/g were used to measure the floor vibrations (Figure 4). The measurement point grid consisted of three vertical reference points and 35 roving vertical measurement points. The latter were covered with five roving sensors in seven setups.

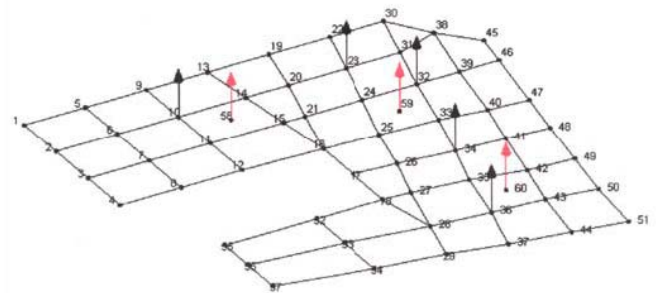
Figure 5. The measurement point grid. The red arrows indicate the position of the three reference sensors (located outside the grid lines), the black arrows the five roving sensors of setup 1.

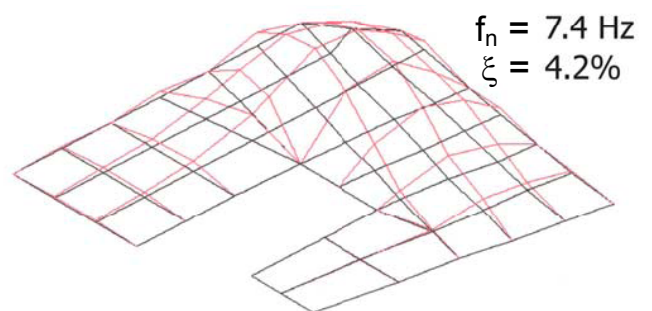
Figure 6. 1<sup>st</sup> Mode of 2<sup>nd</sup> Floor.

The fundamental natural frequencies of the floors were: 2<sup>nd</sup> Floor: 7.4 Hz; 1<sup>st</sup>, 3<sup>rd</sup> and 4<sup>th</sup> Floors: 11.5-12 Hz. The shapes of the 1<sup>st</sup>, 2<sup>nd</sup> and 3<sup>rd</sup> modes as well as the natural frequency  $[f_n]$  and damping  $[\xi]$  (in percentage of critical damping) of the 2<sup>nd</sup> floor are given in the Figures below.

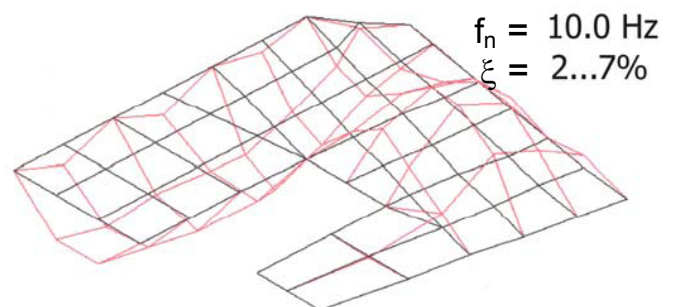
Figure 7. 2<sup>nd</sup> Mode of 2<sup>nd</sup> Floor.

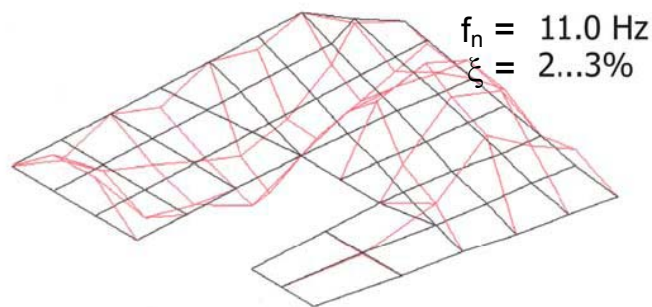
Figure 8. 3<sup>rd</sup> Mode of 2<sup>nd</sup> Floor.

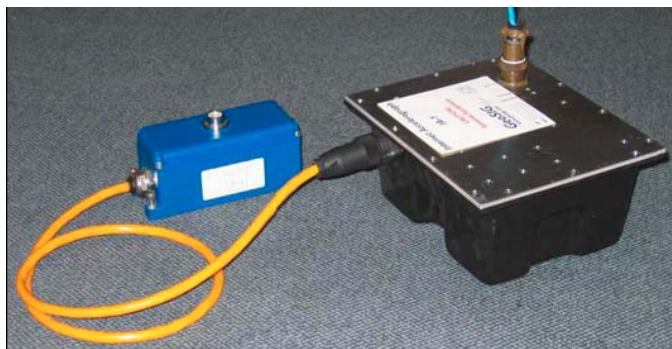
Figure 9. IA-1 with external velocity sensor, used for vibration monitoring.

To monitor the vibration intensity and to identify the source of the vibrations, a triaxial velocity sensor was subsequently mounted in a critical point of the 2<sup>nd</sup> floor slab. The vibrations were monitored for two months using a GeoSIG internet-accelerograph IA-1. This allowed on-line checking of the vibrations and downloading of the data on an external server on a daily basis. The instrument originally has internally mounted accelerometers, but a modified version was deployed with an external GSV-310 velocity sensor for this monitoring project. (Figure 9)

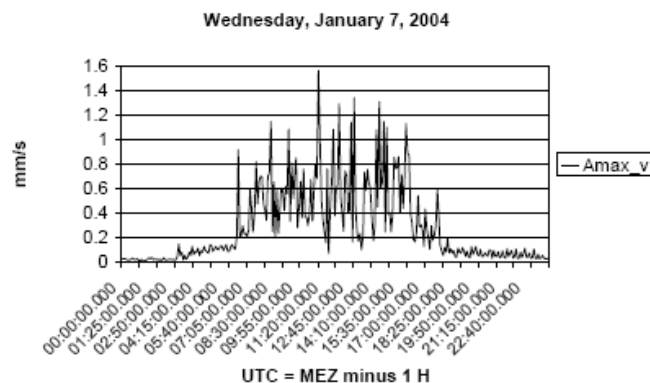
Figure 10. Floor vibrations for a typical normal working day.

Figure 10 to Figure 12 show the peak values of all 288 5-minute-time windows of the vectorial velocity as a function of time for a 24-hours monitoring time. Diagrams of this type were calculated on a daily basis and were used to get a first insight into the behaviour of the floor under investigation. The behaviour as shown in these figures can be called "typical" and covers almost all of the 64 days of undisturbed 24-hours monitoring. These "typical" diagrams, identically scaled on the

ordinate, include a normal working day (Figure 10), a typical Saturday (Figure 11) and a typical Sunday (Figure 12).

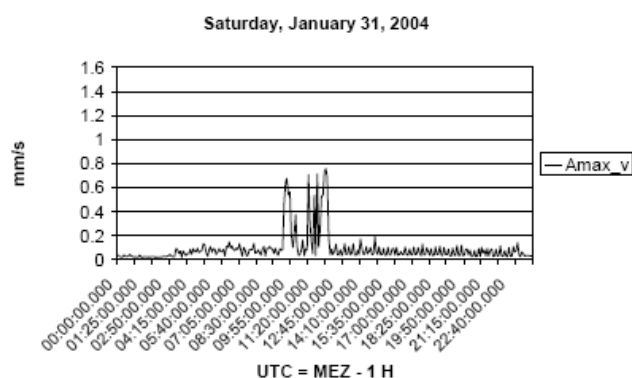
Figure 11. Floor vibrations for a typical Saturday.

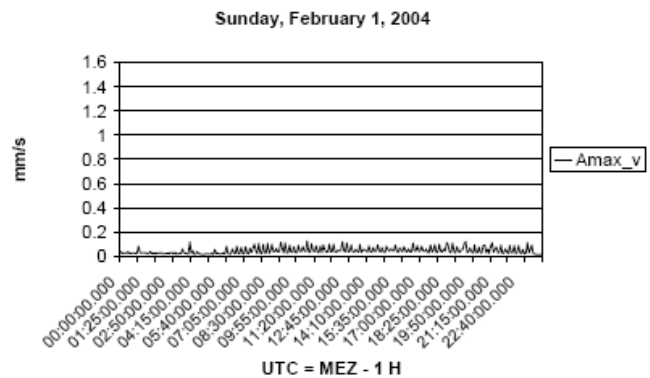
Figure 12. Floor vibrations for a typical Sunday.

Therefore, as a first result of the monitoring tests, it could be noted that no other source could be identified than people walking on the floor.

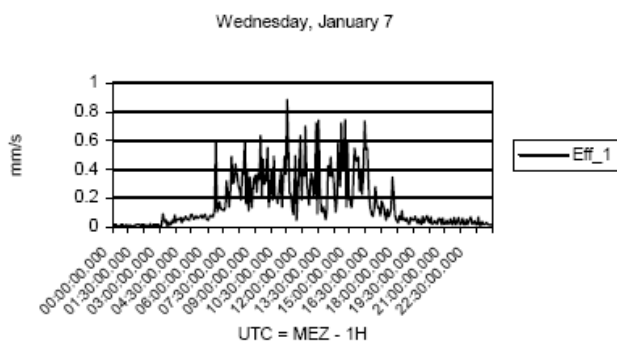
Figure 13. Floor vibrations for a typical normal working day.

The measured vibrations were therefore rated according to ISO 2631-1 (1997) and ISO 2631-2 (1989). This rating is based on measured RMS-values of acceleration or velocity. Processing the signals using the GeoDAS software package allowed plotting similar graphics as shown in the Figure 10 to Figure 12 for RMS- instead of peak values (Figure 13).

- normal working day:  $v_{RMS}=0.47-1.45$  mm/s, 0.8 mm/s on the average,
- nobody present:  $v_{RMS}=0.07-0.17$  mm/s, 0.11 mm/s on the average.

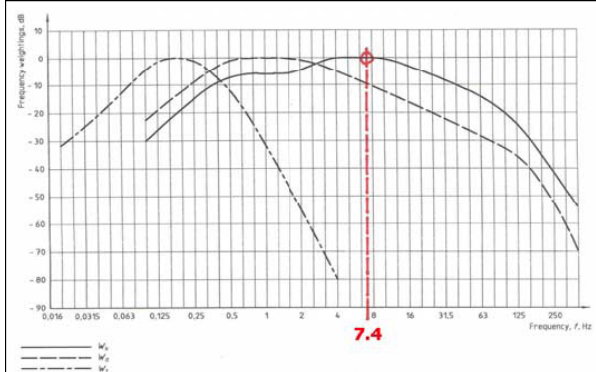
Figure 14. Frequency weighting curves as given in ISO 2631-1 (1997).  $W_k$  (solid line) applies for vertical movement.

- the frequency weighting curve (Figure 14),
- the base curve (Figure 15), and
- the multiplication factor.

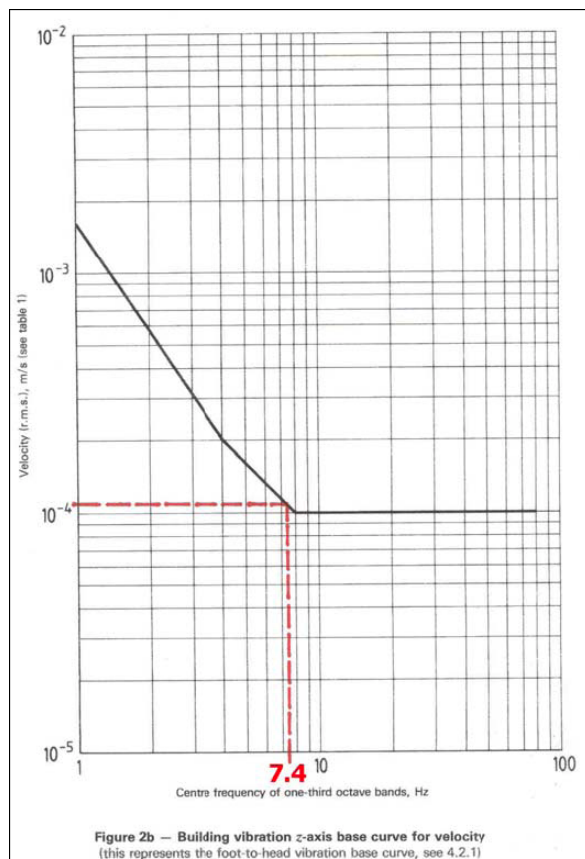
Figure 15. Base value for  $f = 7.4$  Hz (ordinate's scaling: m/s).

For office buildings, "continuous or intermittent vibration", "day" and "night", Table 2 of ISO 2631-2 (1989) gives a multiplication factor 4.
